**CORROSION TESTS OF LITHIUM FLUORIDE
IN CONTACT WITH COLUMBIUM ALLOYS**

TOPICAL REPORT II

LITHIUM FLUORIDE BELLOWS CAPSULE TESTS

January 29, 1970

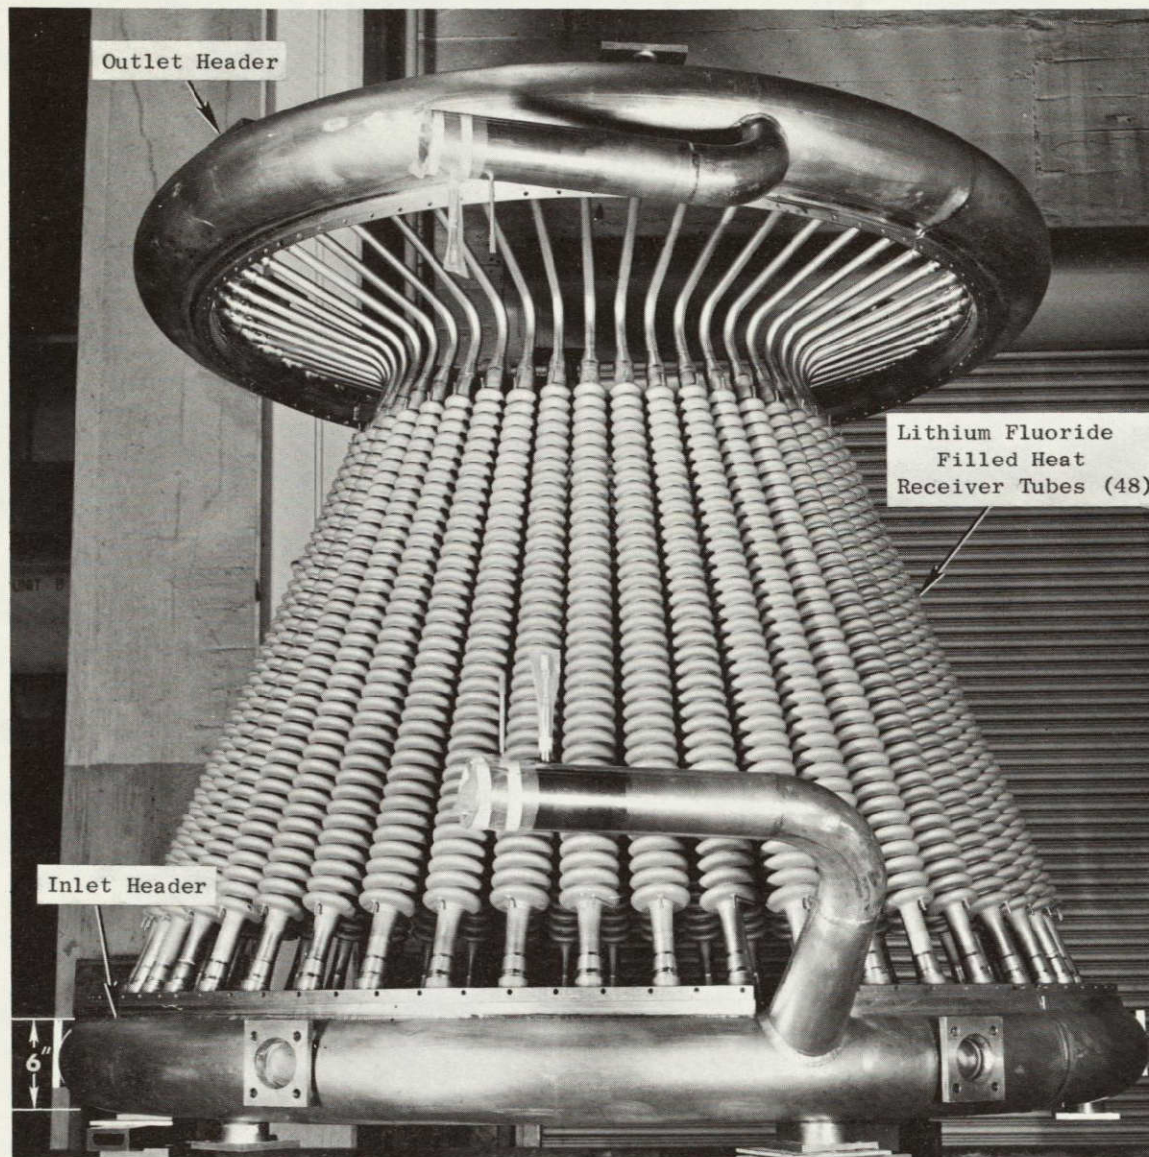
Figure 1. Cb-1Zr Solar Brayton Cycle Heat Receiver
During Fabrication. (P69-11-12D)

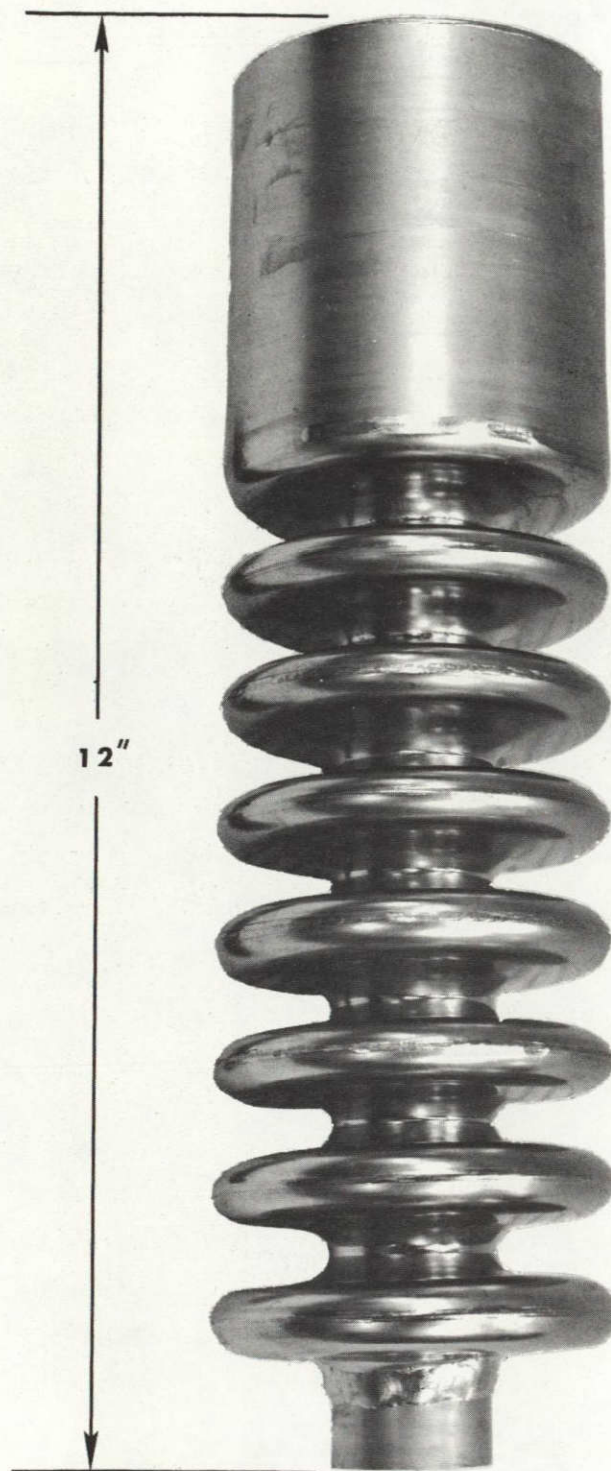
Figure 2. Cb-1Zr Bellows Capsule I Simulating a Lithium Fluoride Brayton Cycle Heat Receiver.

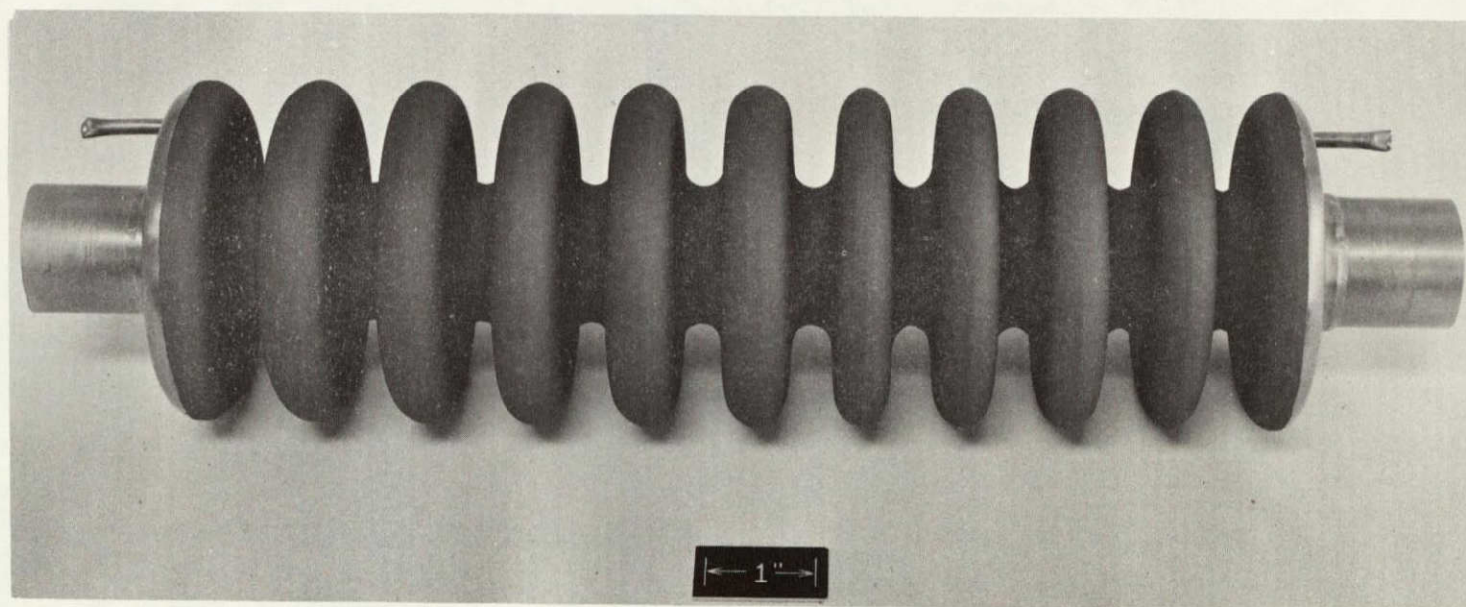
Figure 3. Iron Titanate Coated Bellows Capsule II. (C67091940)

Bellows Capsule II and III shown in Figures 3 and 4 more closely resemble the heat receiver tube geometry since they were fabricated and filled with lithium fluoride using techniques developed for the heat

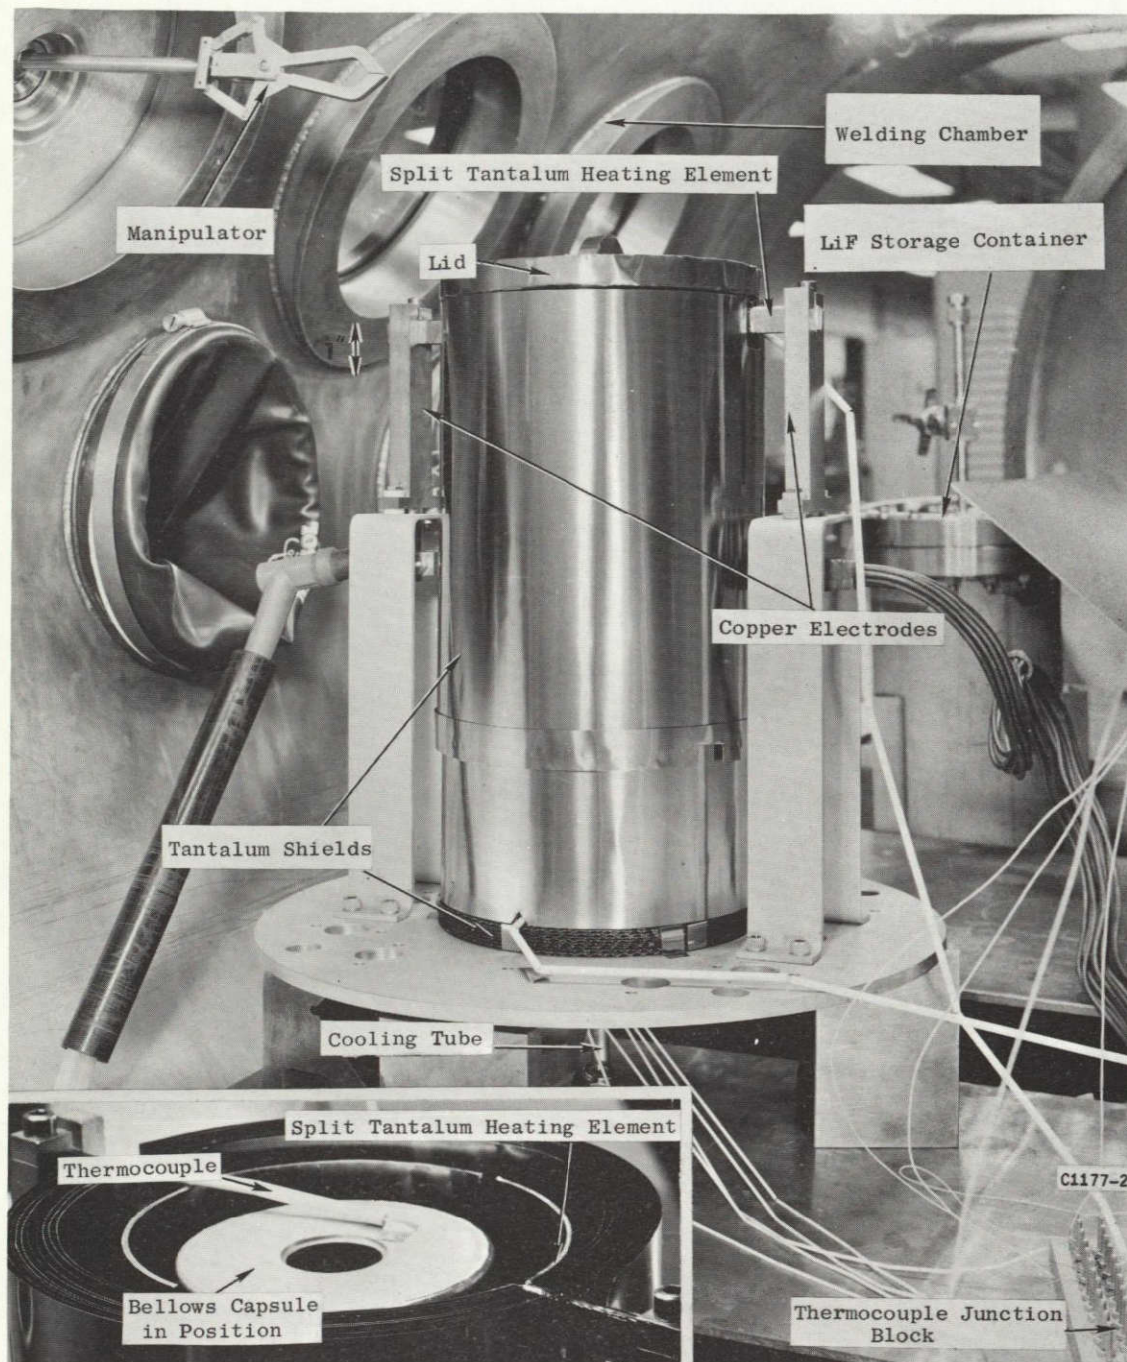
Figure 5. Bellows Capsule Lithium Fluoride Filling Facility Assembled in the Welding Chamber. Inset Photograph at Lower Left Shows the Top of the Assembly with the Insulating Lid Removed. (C67011370 & C67011351)

The bellows capsule was filled with lithium fluoride at NSP Evendale. The bellows capsule filling facility is shown in the welding chamber in Figure 5. The capsule was positioned in the split tantalum heating elements by means of the Cb-lZr cooling tube and instrumented with thermocouples on the filling chamber top and the bottom convolution as shown in Figure 6. It was necessary to use a Cb-lZr cooling tube during the filling operation rather than a stainless steel cooling tube of the type to be used in the test facility since the cooling tube would reach the capsule temperature (1900°F) during filling. The vapor pressure of stainless steel at this temperature in vacuum would have resulted in contamination of the ID of the Cb-lZr bellows capsule during this operation. Similarly helium was used for cooling to prevent oxidation of the inside surfaces of the Cb-lZr cooling tube. The cooling tube was required in the filling operation for the same reasons as required in the test facility, namely, to produce a desirable lithium fluoride freezing pattern.

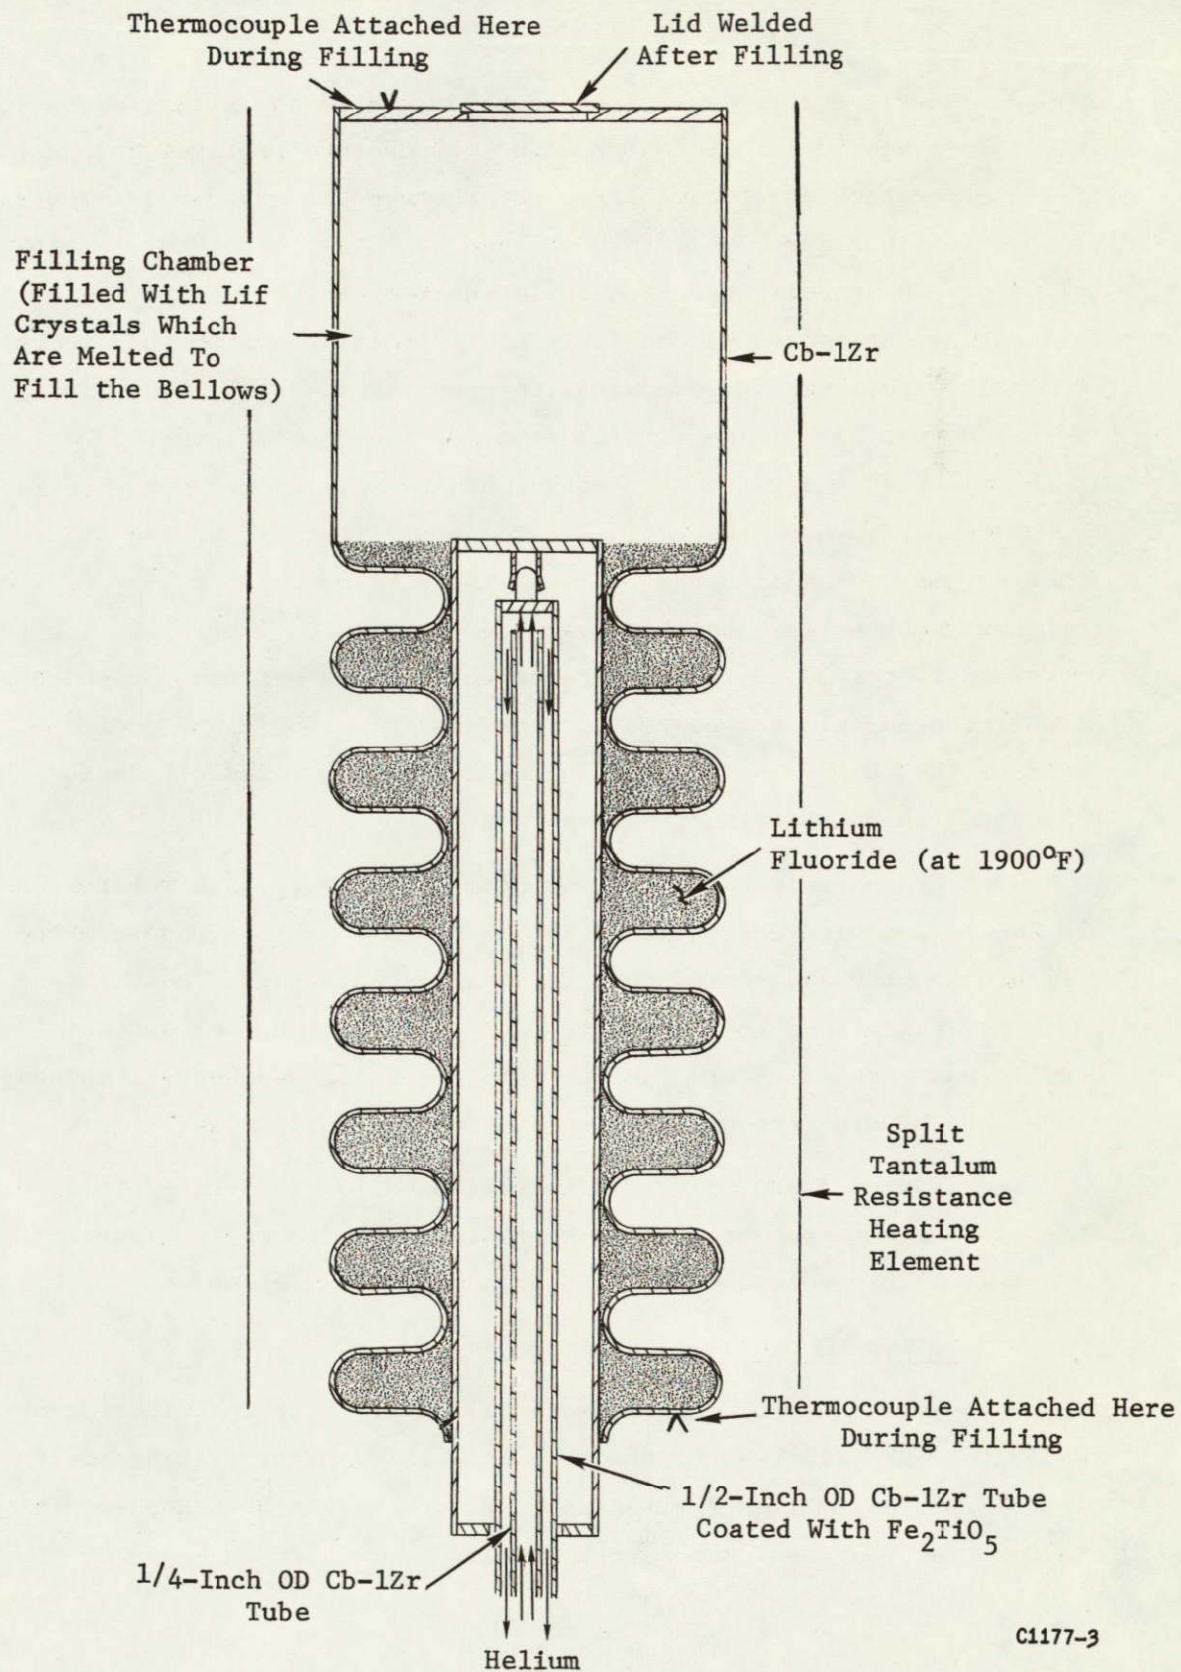
Figure 6. Cb-1Zr Bellows Capsule Filling Schematic Showing the Position of the Monitoring Thermocouples.

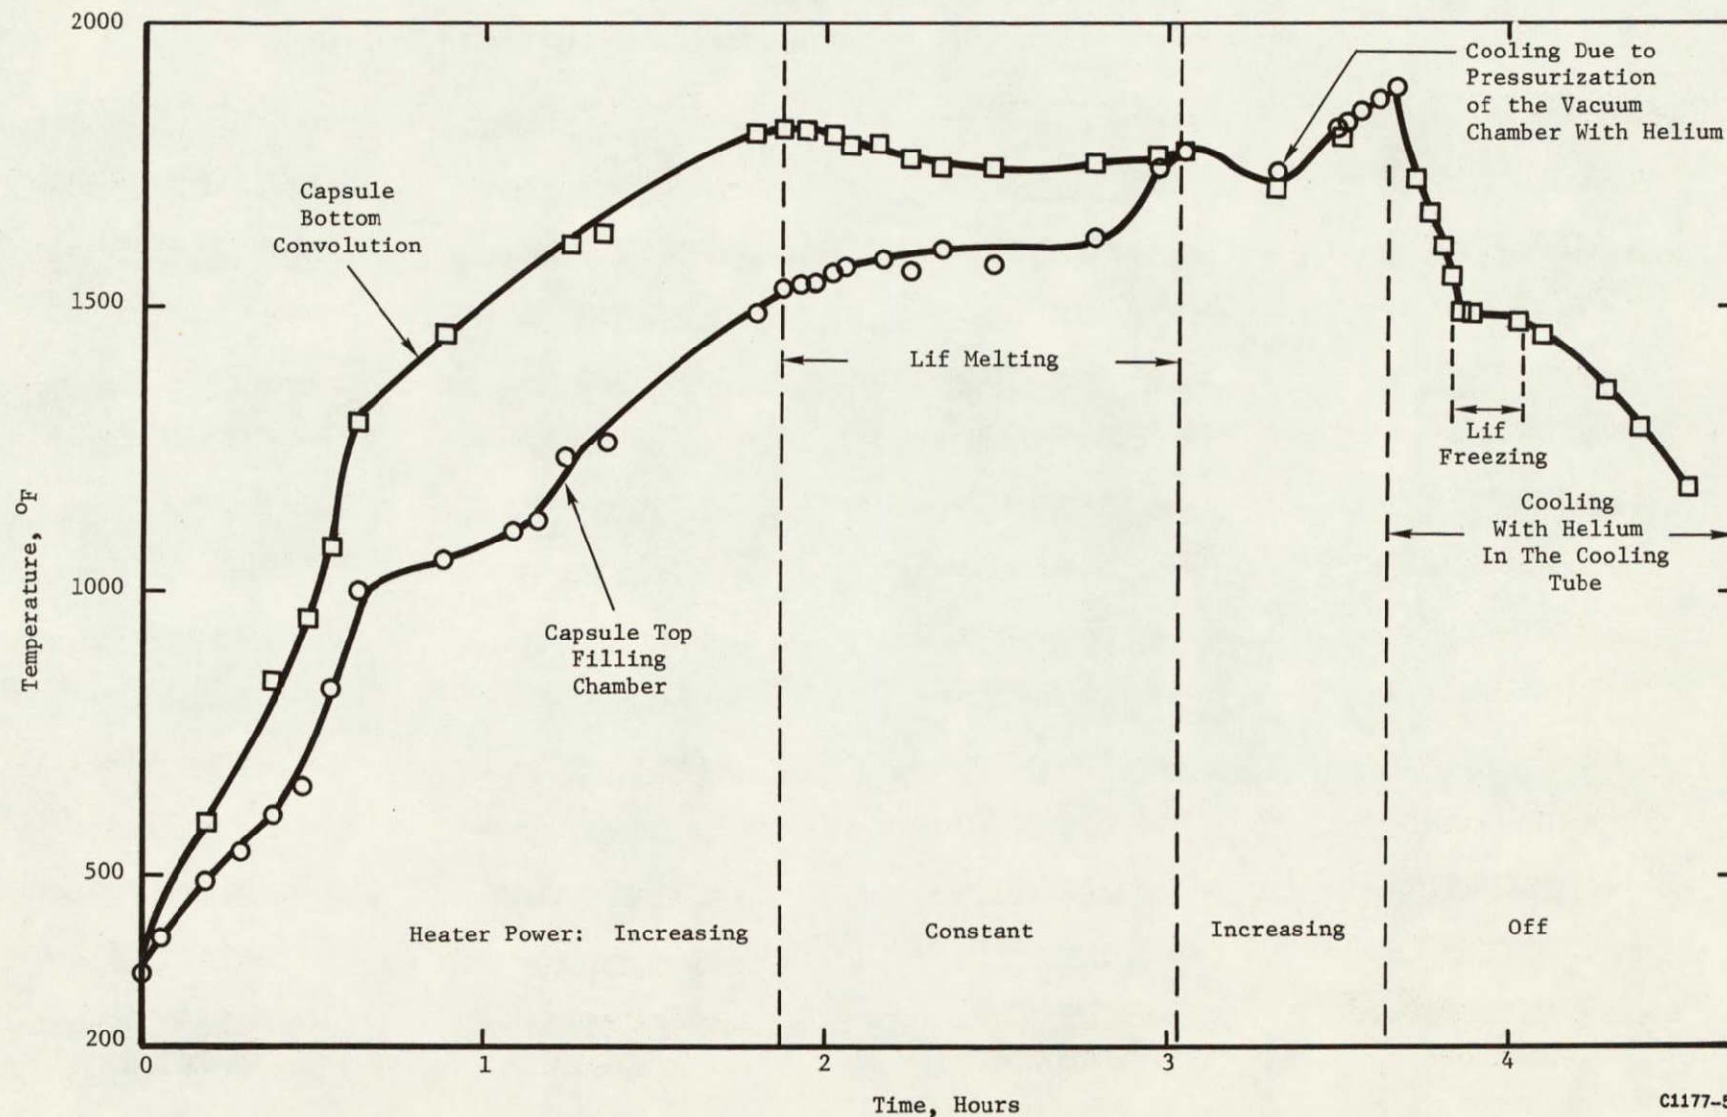
Figure 7. Temperature Profile of Bellows Capsule I During the Lithium Fluoride Filling Operation.

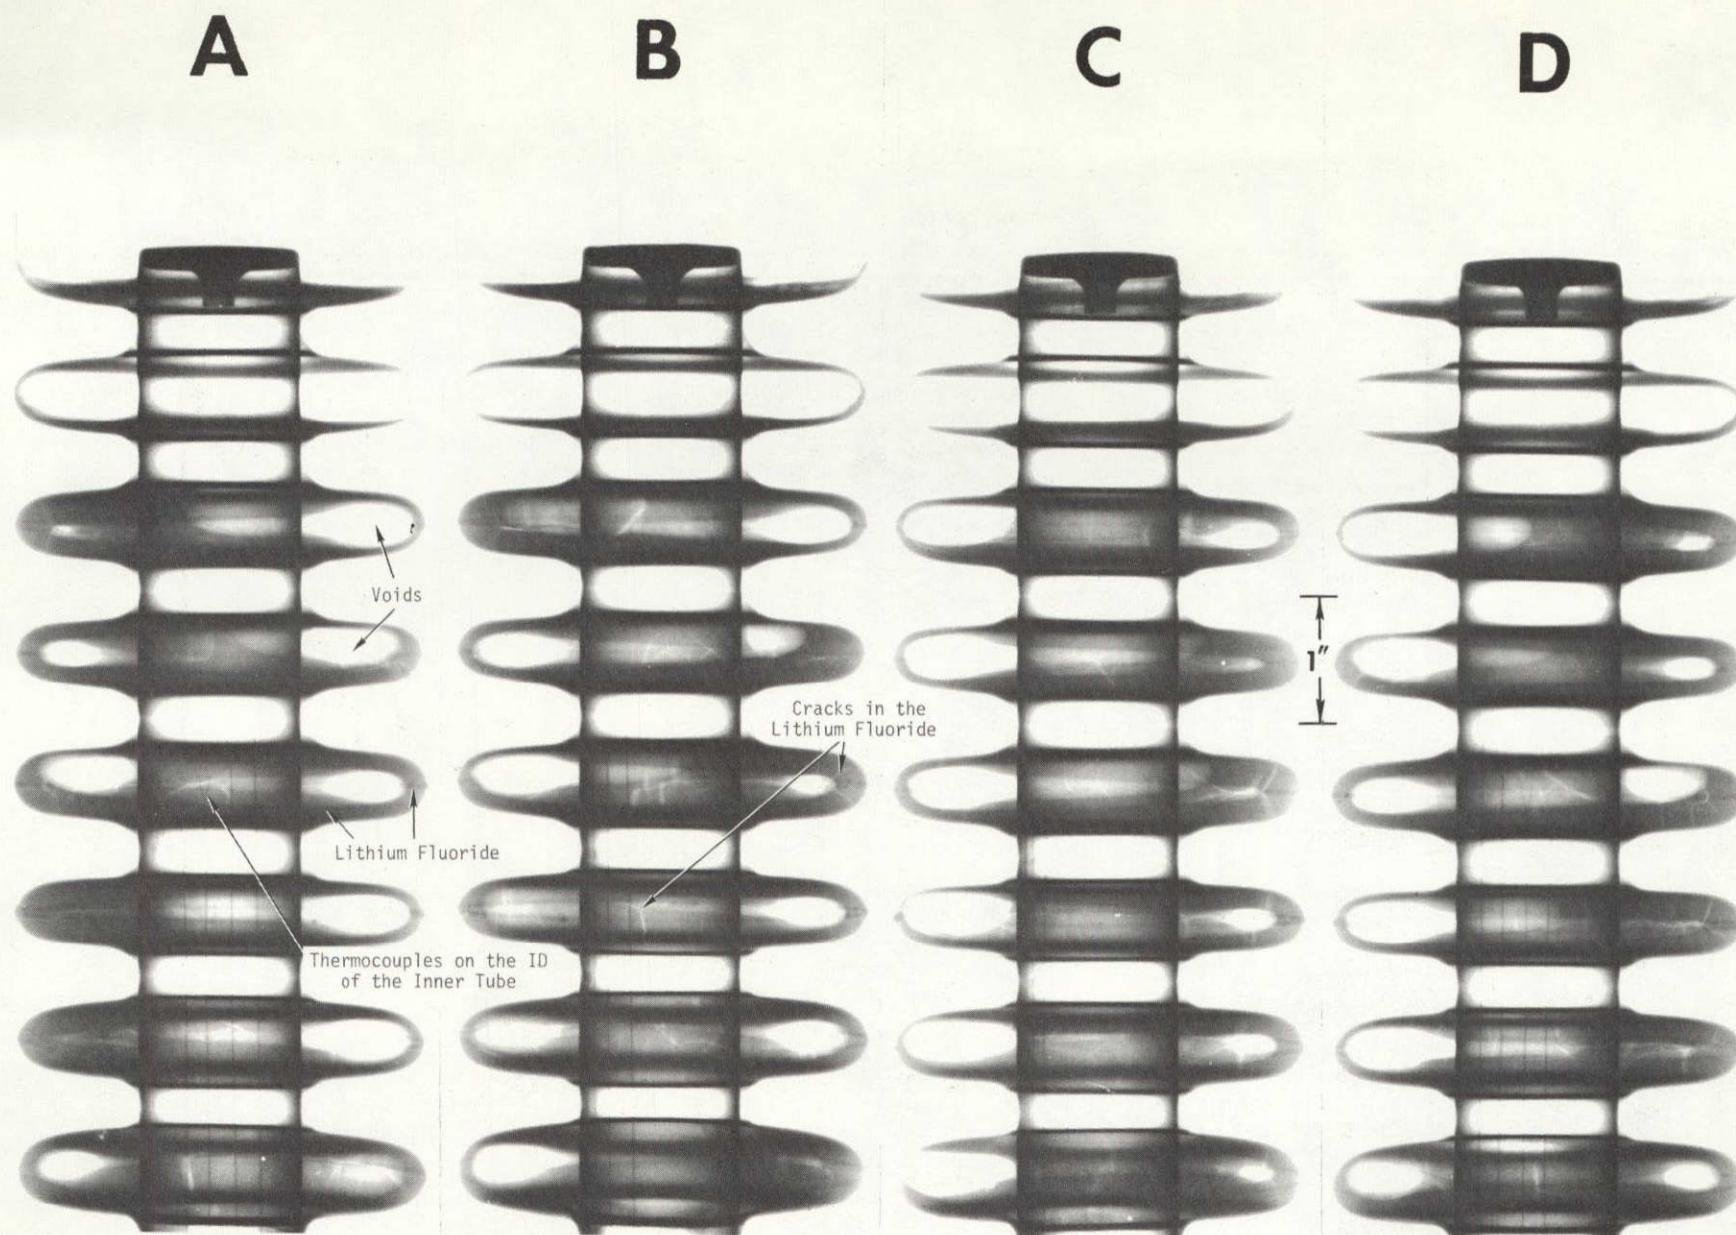
Figure 8. Radiographs of the Lithium Fluoride Filled Bellows Capsule I.

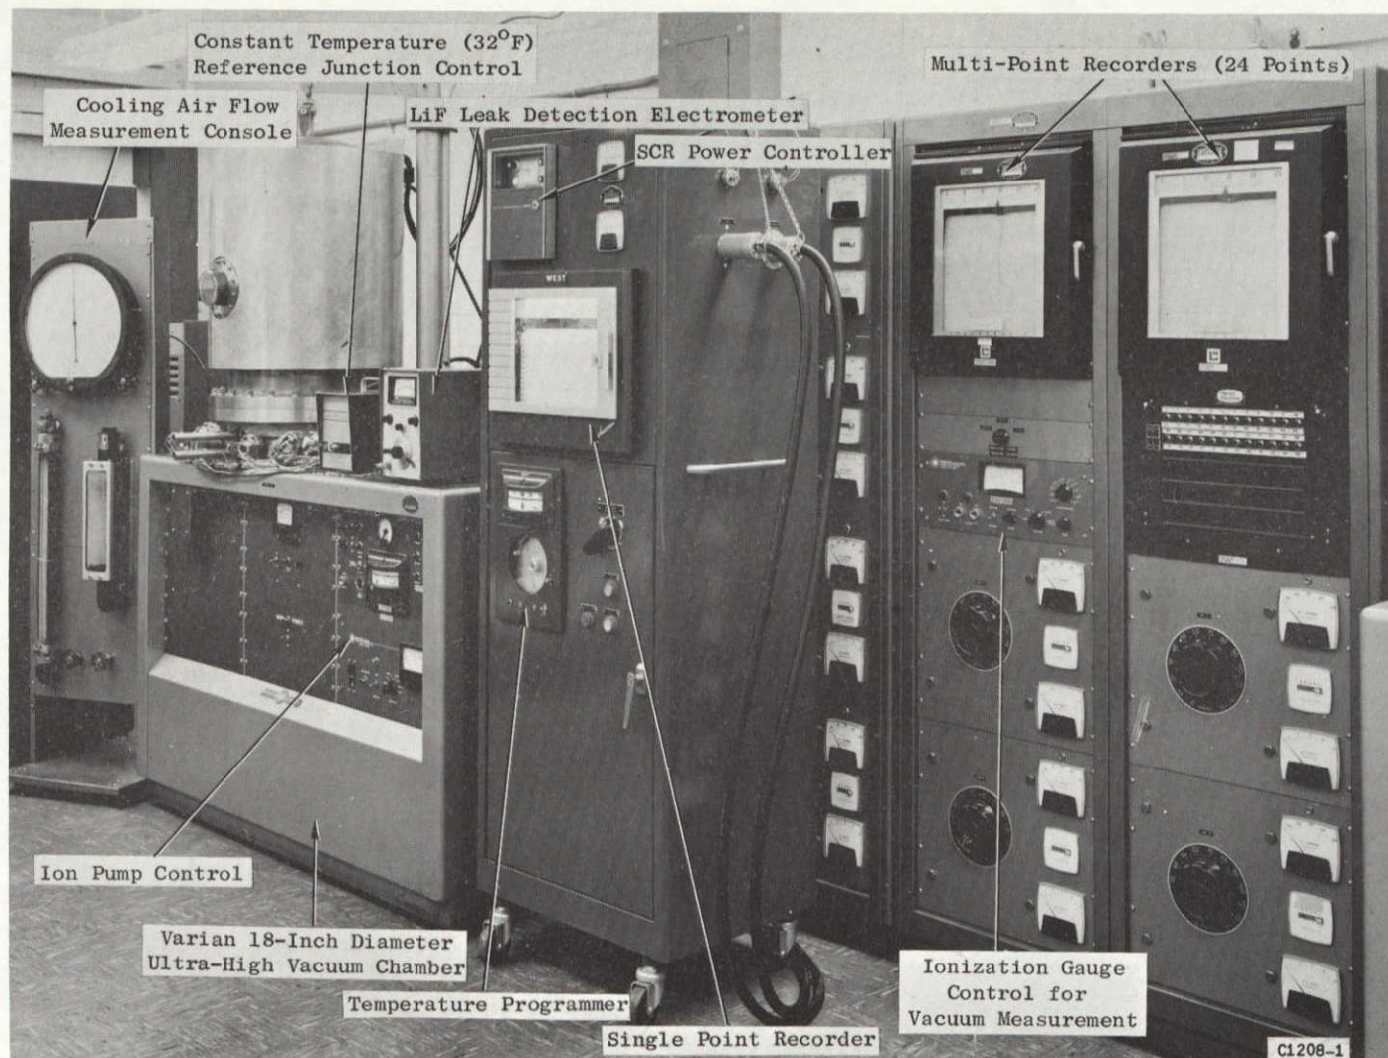
Figure 9. The Lithium Fluoride Bellows Capsule Test Facility. (C67031423)

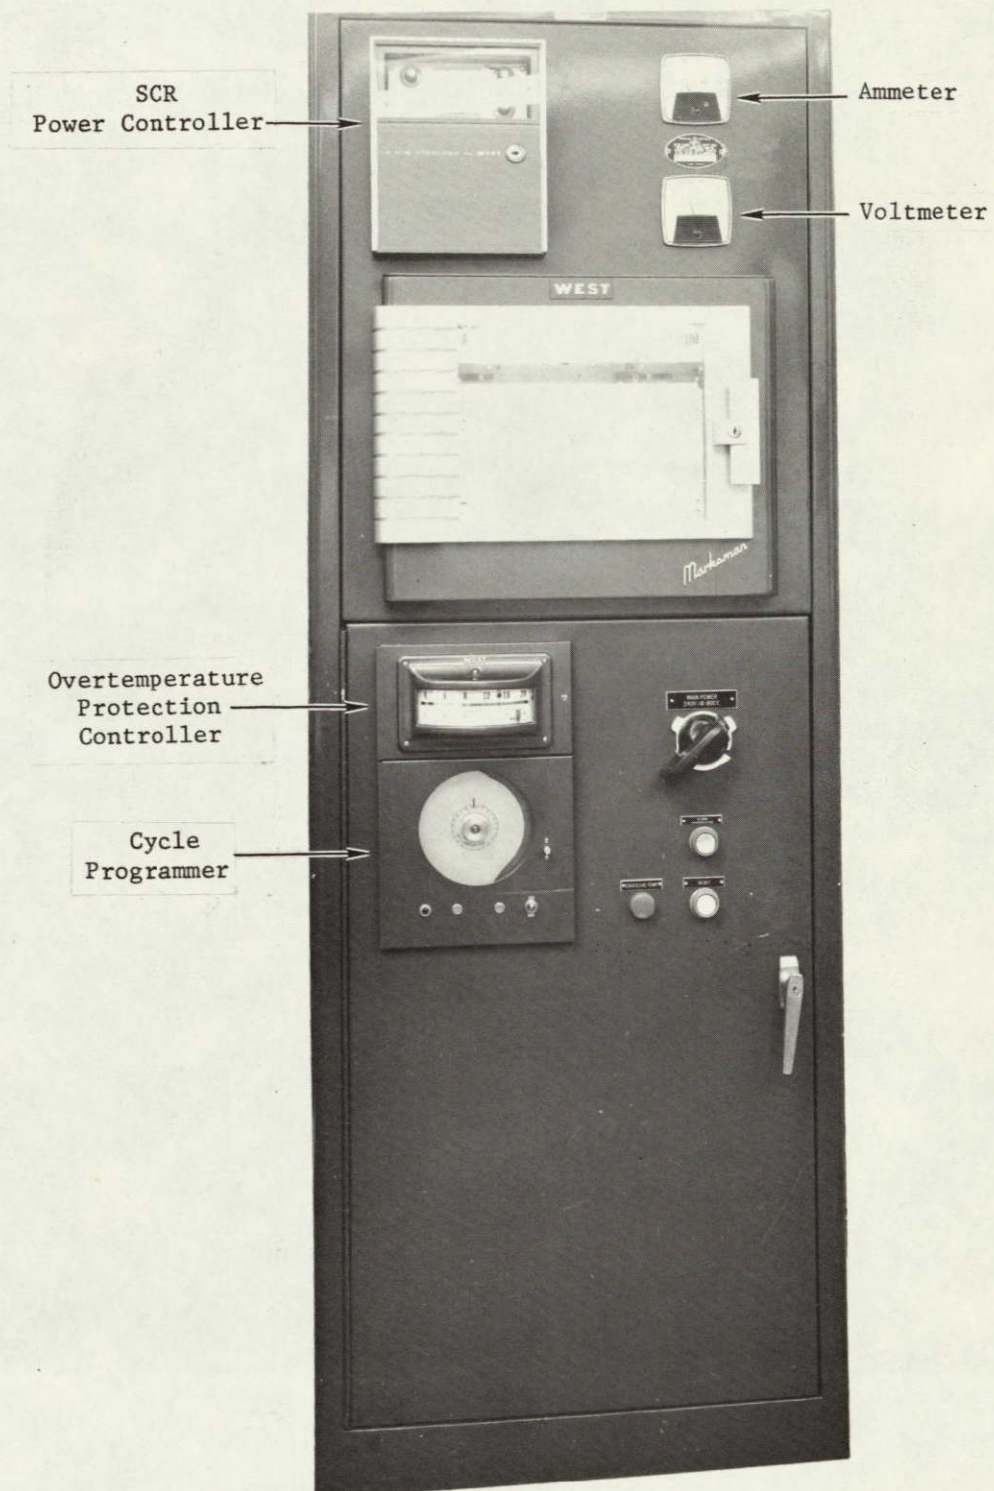
Figure 10. Temperature Cycle Control System Lithium Fluoride Bellows Capsule Tests. (C68022940)

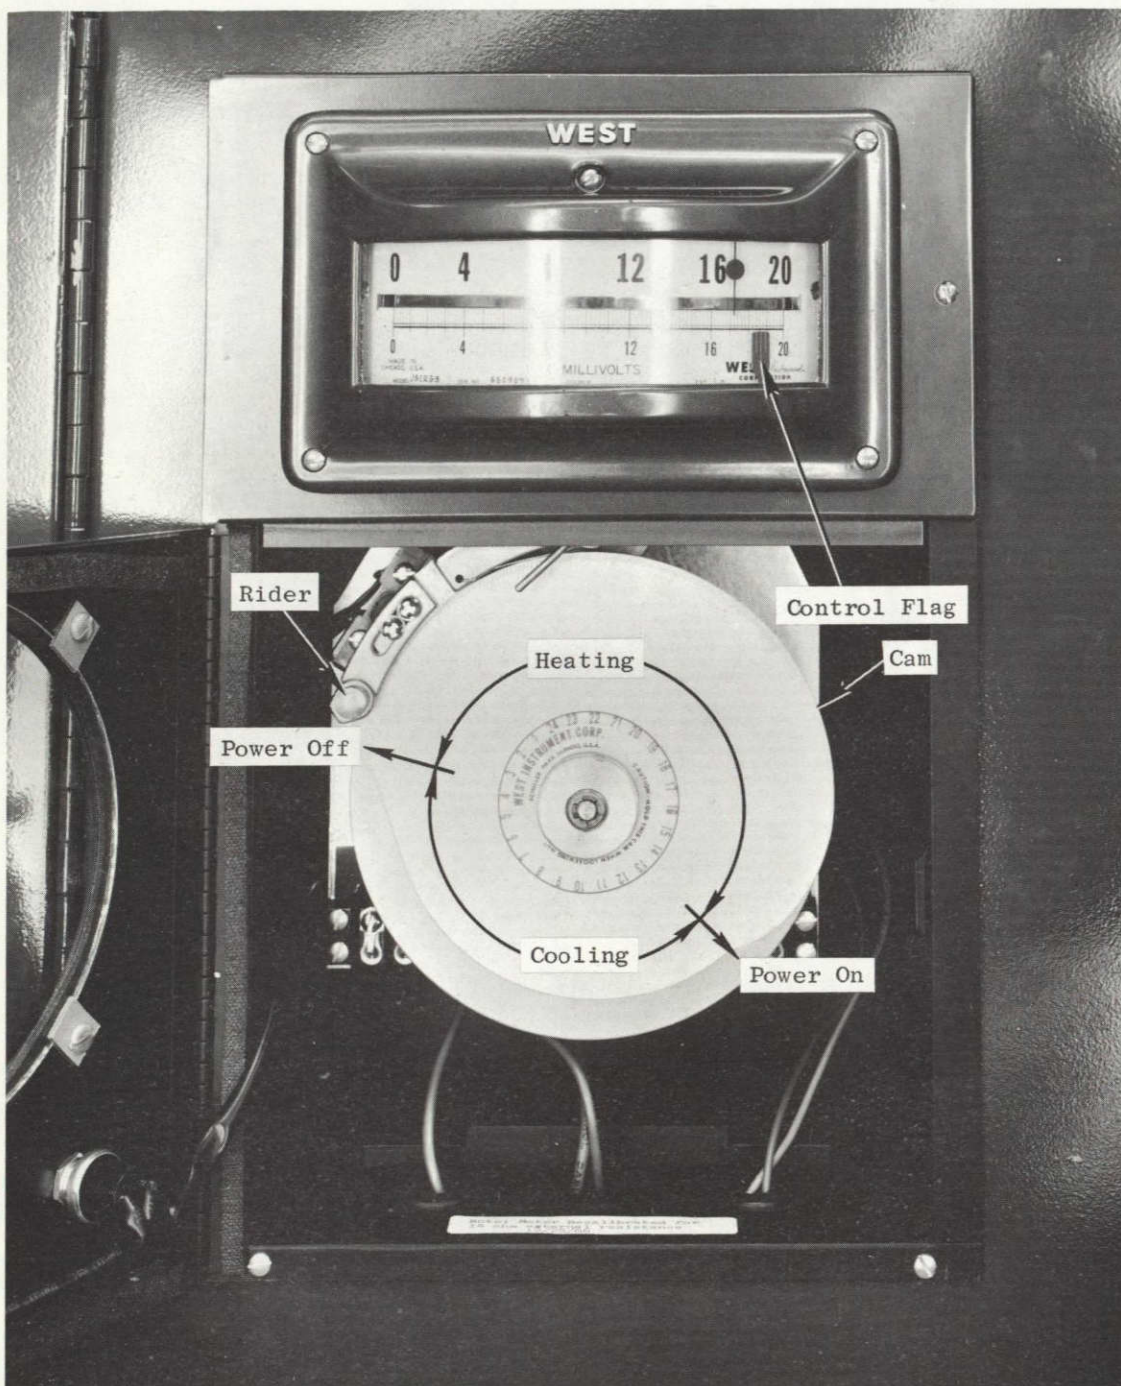
Figure 11. Cam Controlled Temperature Programmer - Lithium Fluoride Bellows Capsule Tests. (C67031427)

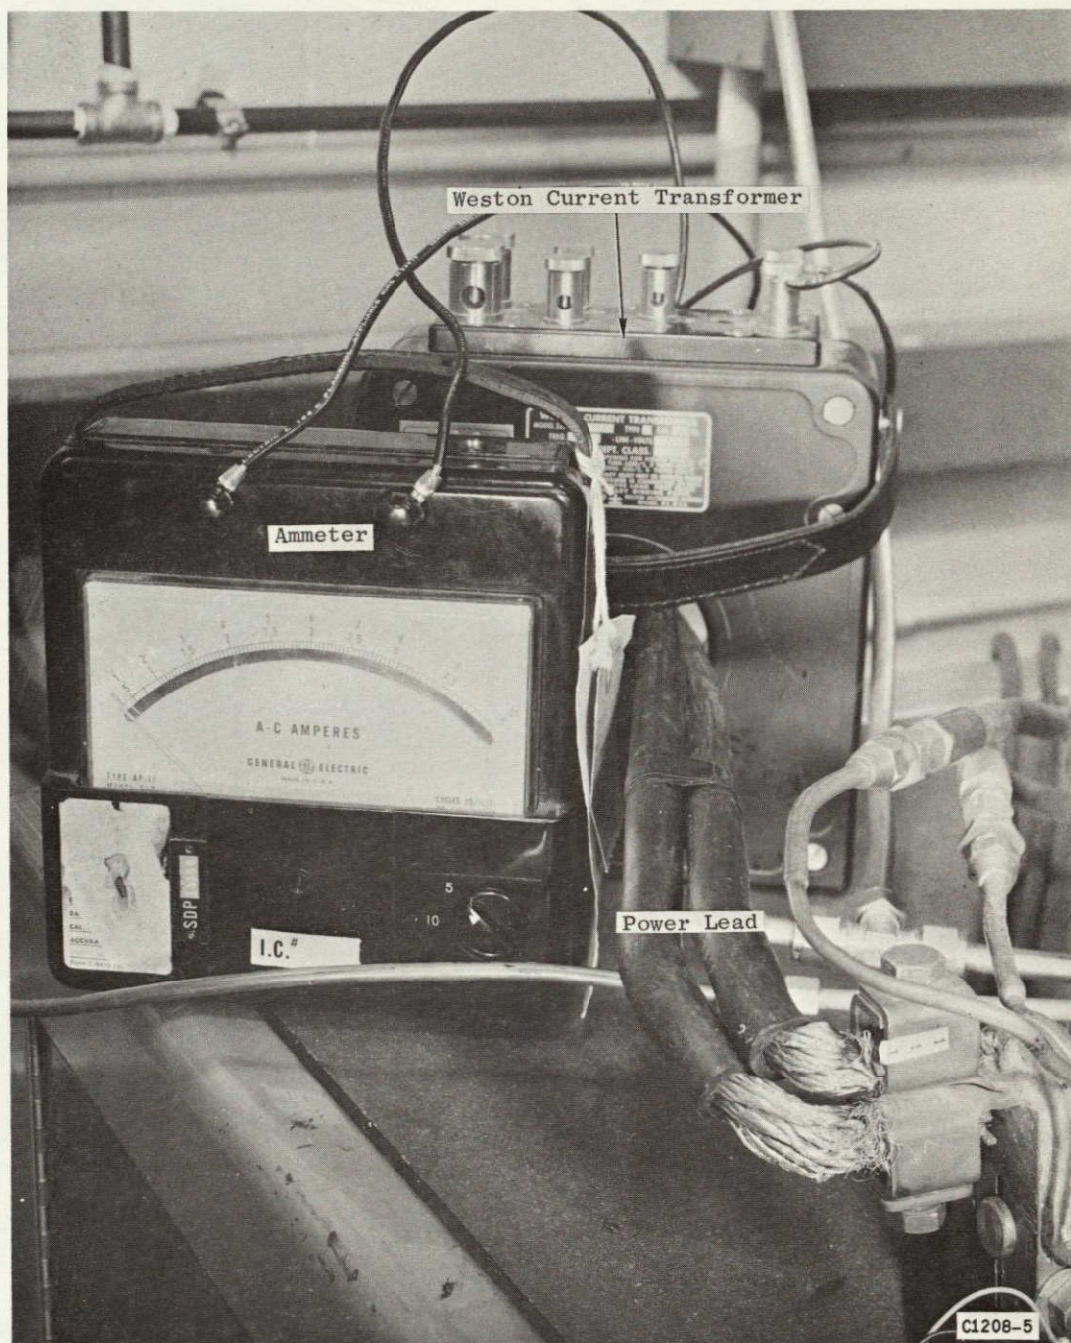
Figure 12. Current Measuring Instruments Employed in the Lithium Fluoride Bellows Capsule Tests. (C67031428)

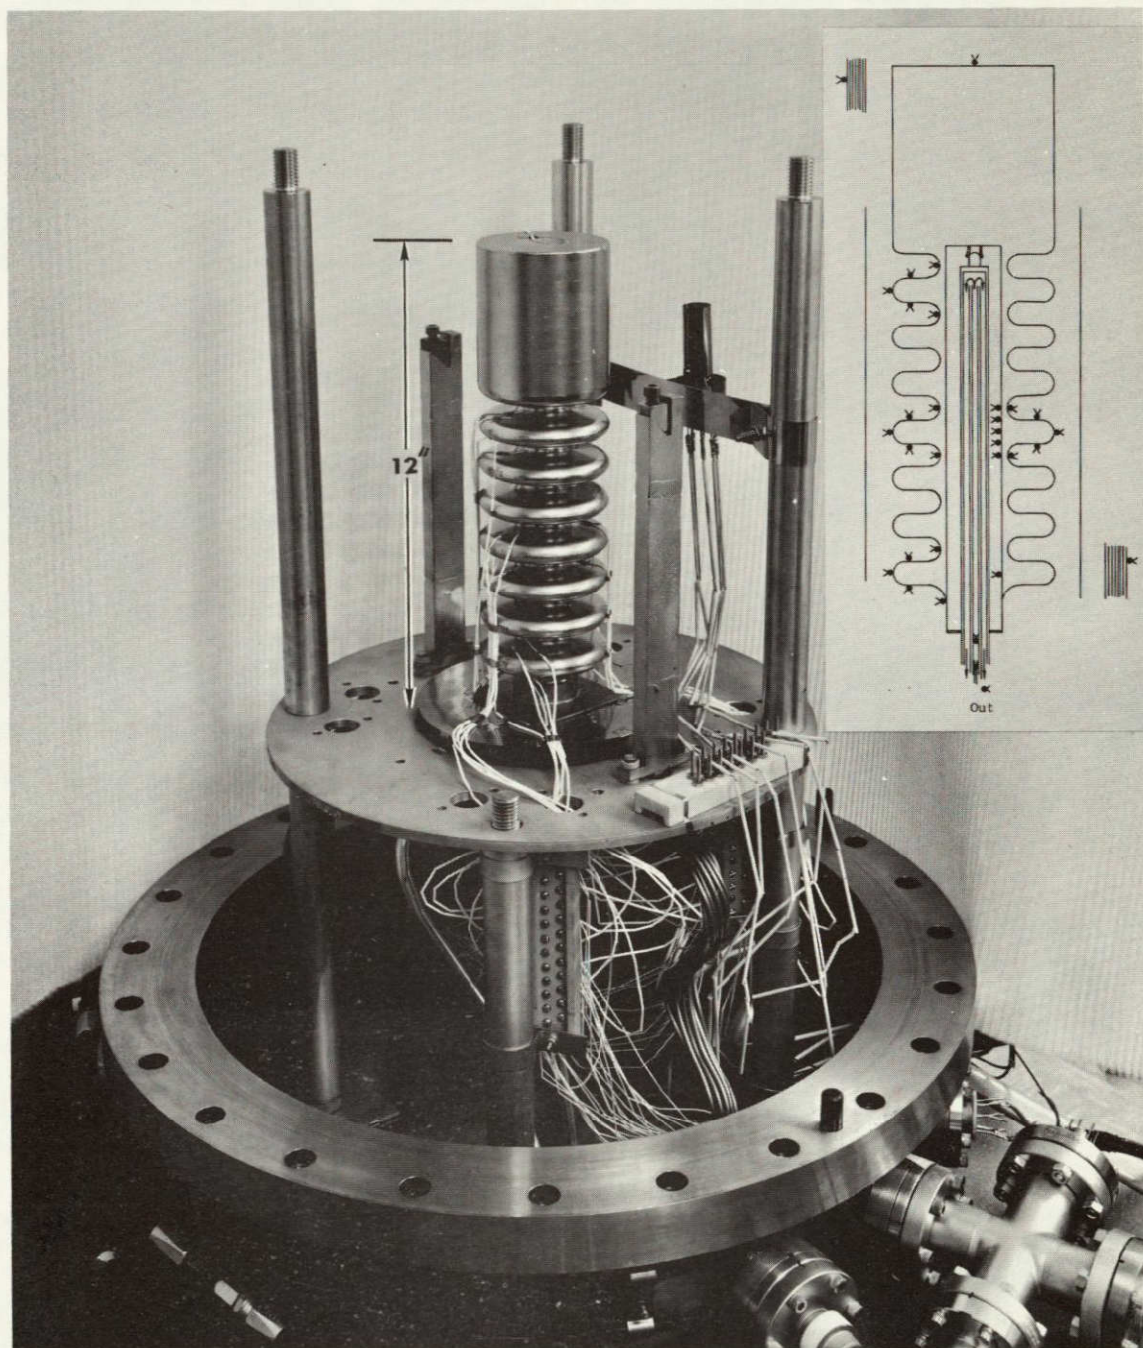
Figure 13. Thermocouple Installation Lithium Fluoride
Bellows Capsule I. (C67021522)

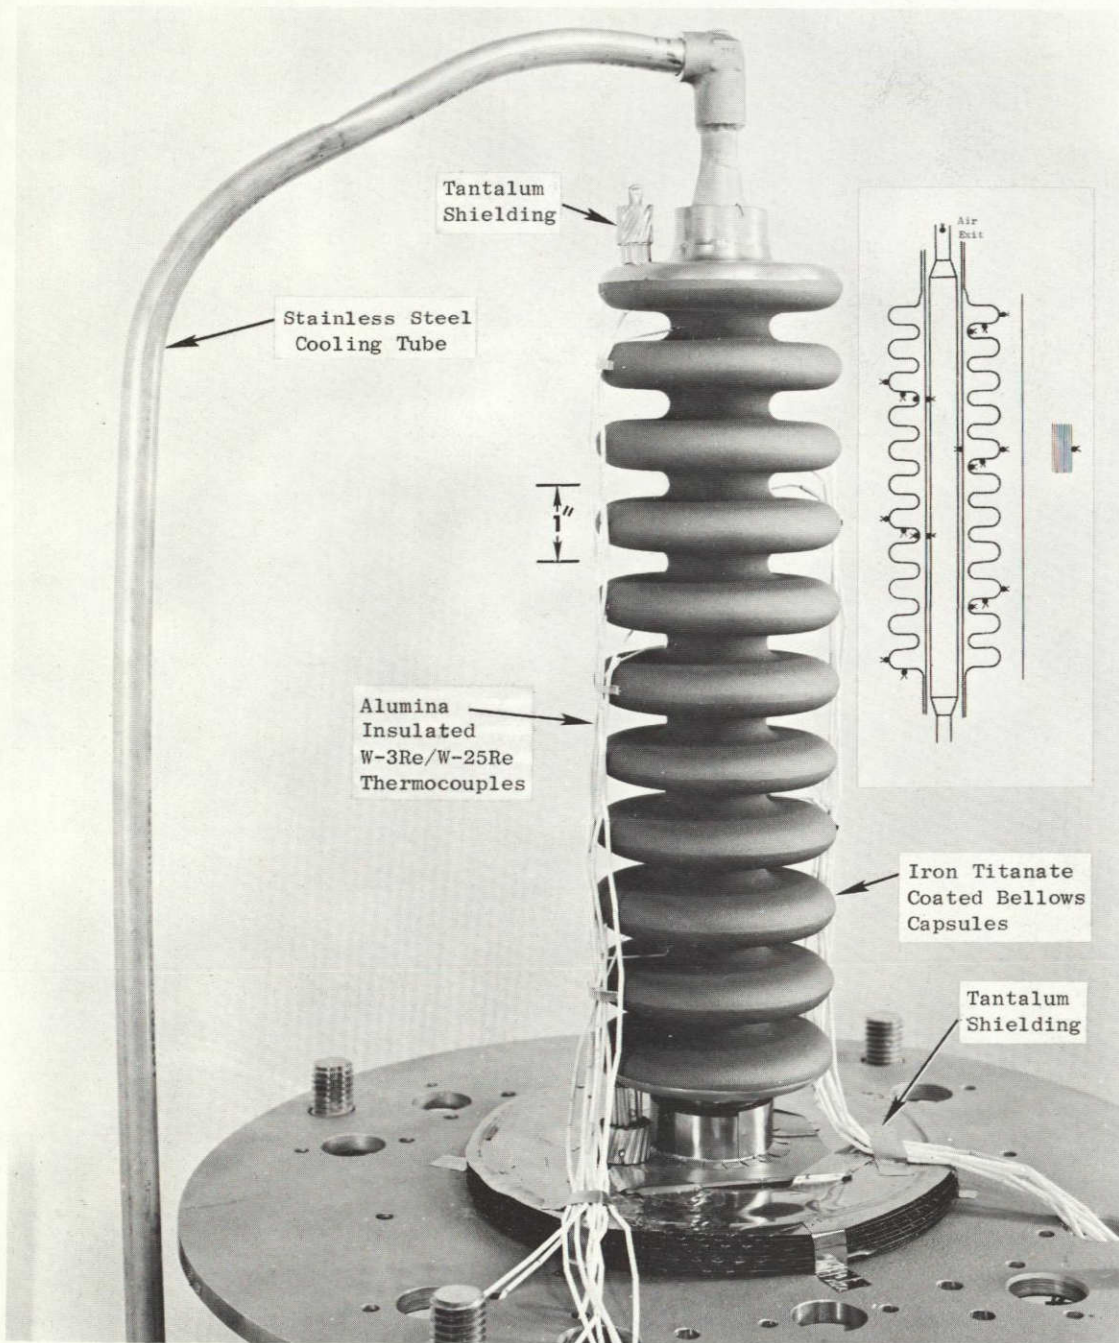
Figure 14. Thermocouple Installation Lithium Fluoride Bellows Capsule II. (C67102622)

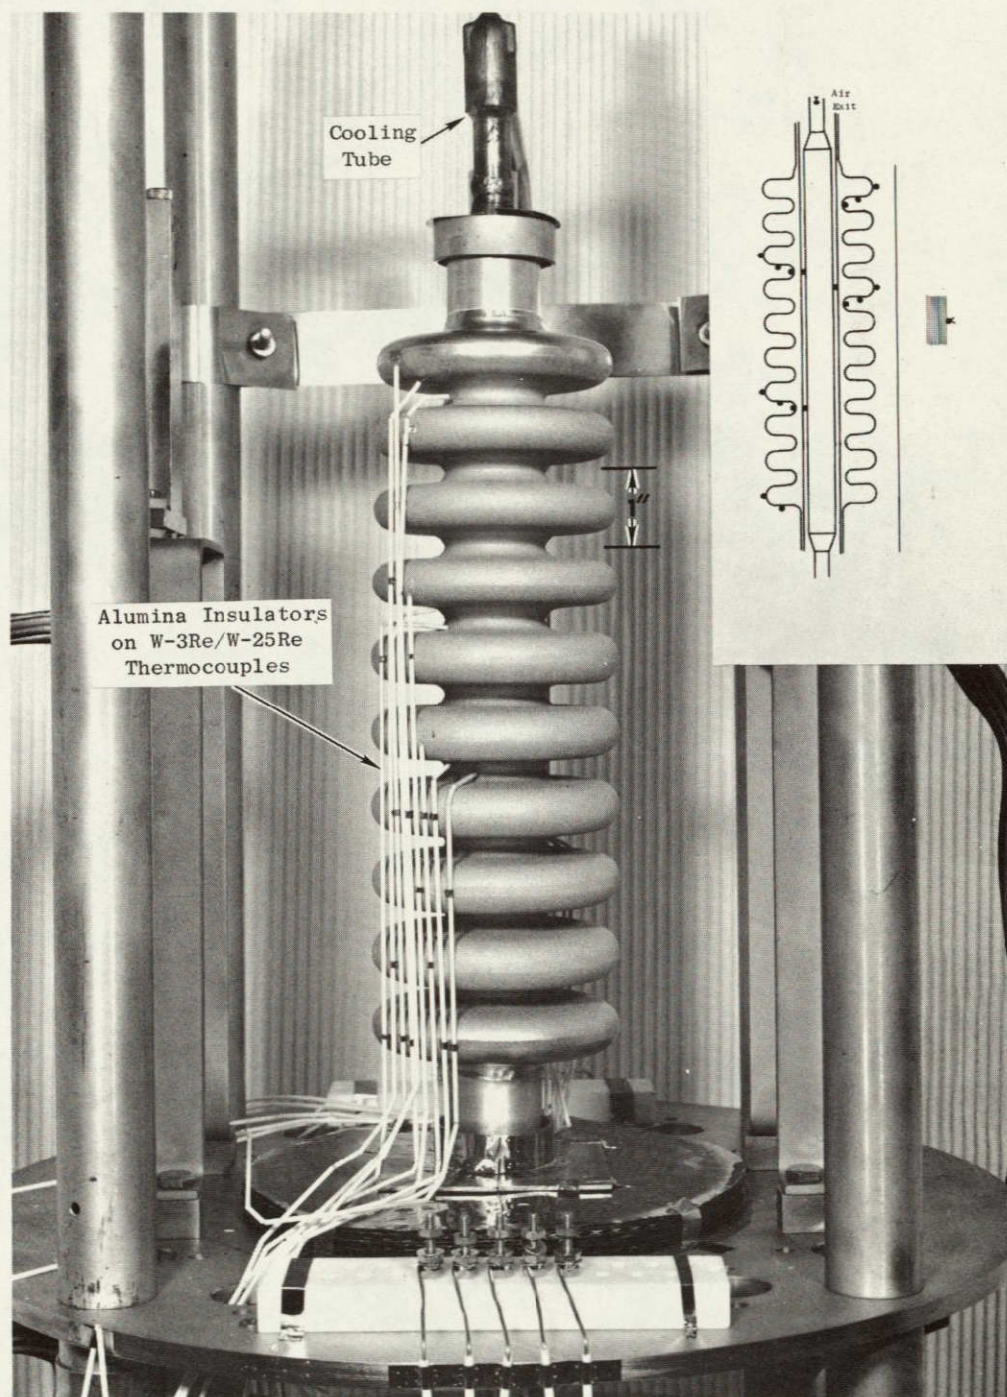
Figure 15. Thermocouple Installation Lithium Fluoride Bellows Capsule III. (P69-1-27E)

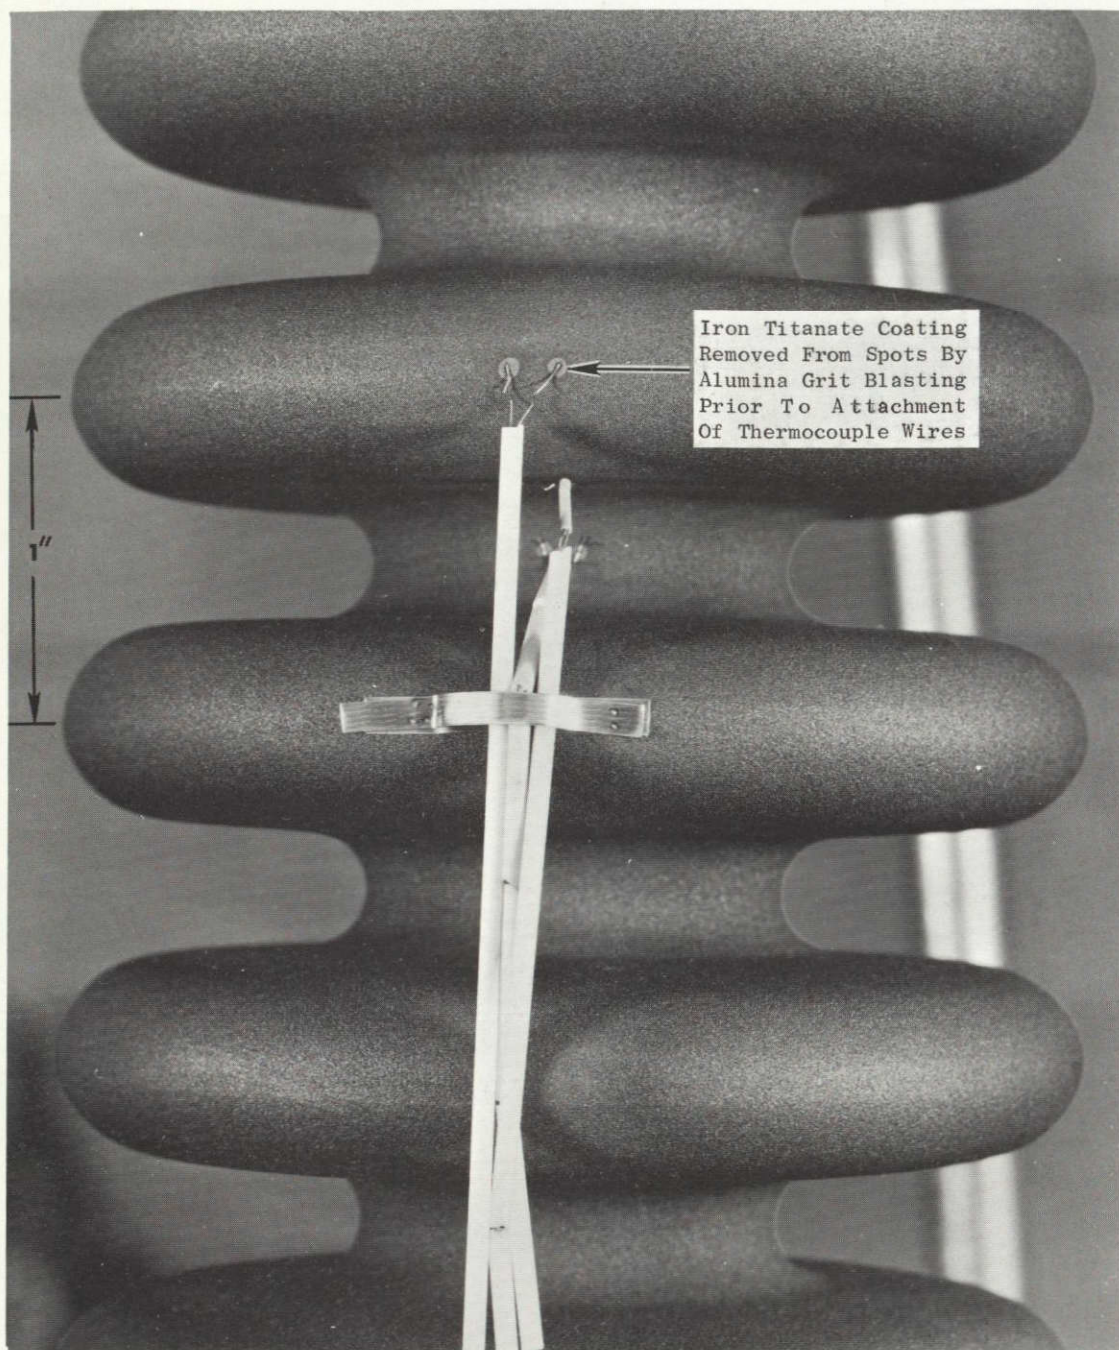
Figure 16. Thermocouple Installation Lithium Fluoride Bellows Capsule II. (C67102624)
